FEASIBILITY STUDY OF BUILDING SEISMIC DAMAGE ASSESSMENT USING OBLIQUE PHOTOGRAMMETRIC TECHNOLOGY

ABSTRACT

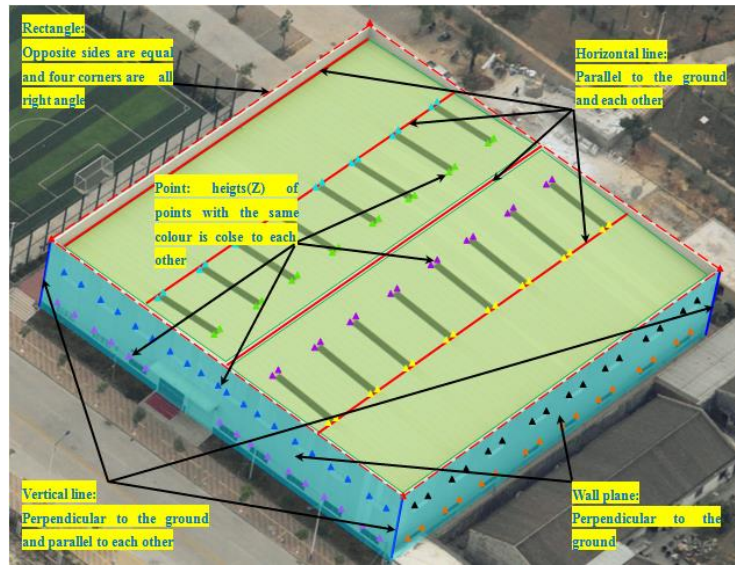
Fig. 1. Geometric features on the outer surface of building

Points, lines, polygons (mainly refer to rectangles), planes, etc. are all geometric features on the outer surface of building. These features meet certain geometric constraints when the building is not damaged, but some or all of them may change when the building is damaged, as is shown in Tab. 1 and Fig. 1.

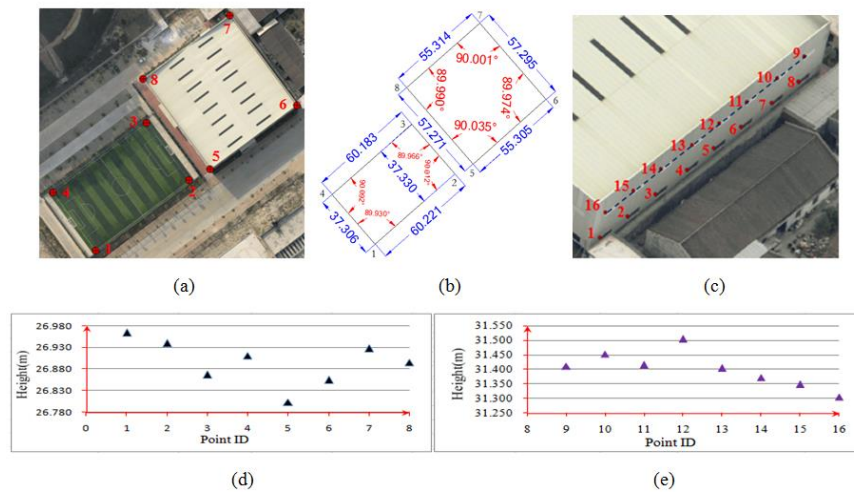
Fig. 2. Study areas and calculation results; (a) feature points of ground objects in vertical image; (b) the projection of ground objects on X-Y plane; (c) feature points of the wall in oblique image; (d) and (e) are height diagrams

Two experiments have been conducted on undamaged building in order to test the reliability of damage assessment rules in this section. Experiment one: as shown in Fig.2 (a), there are a football field and a building in study area one. The coordinates of feature points on these ground objects are calculated and projected to X-Y plane as is shown in Fig.2(b), rectangular profiles of the ground objects are

meeting following rules: $|l_1 - l_2| < 0.2, |\gamma - 90| < 0.2$. Experiment two: study area two in Fig.2(c) is a wall of the building. Two groups (Point ID: 1-8, 9-16) of feature points which are located in the same elevations respectively are selected and calculated. The maximal differences between height values of points at the same group is less than 0.2 m ($|\delta| \leq 0.2$); the angle (α) between dotted line and normal vector of the ground is 90.122° ($|\gamma - 90| < 0.5$); the angle
